# RESEARCH MEMORANDUM

CYCLIC ENGINE TEST OF CAST VITALLIUM

TURBINE BUCKETS - II

By J. Elmo Farmer, George C. Deutsch  
and Paul F. Sikora

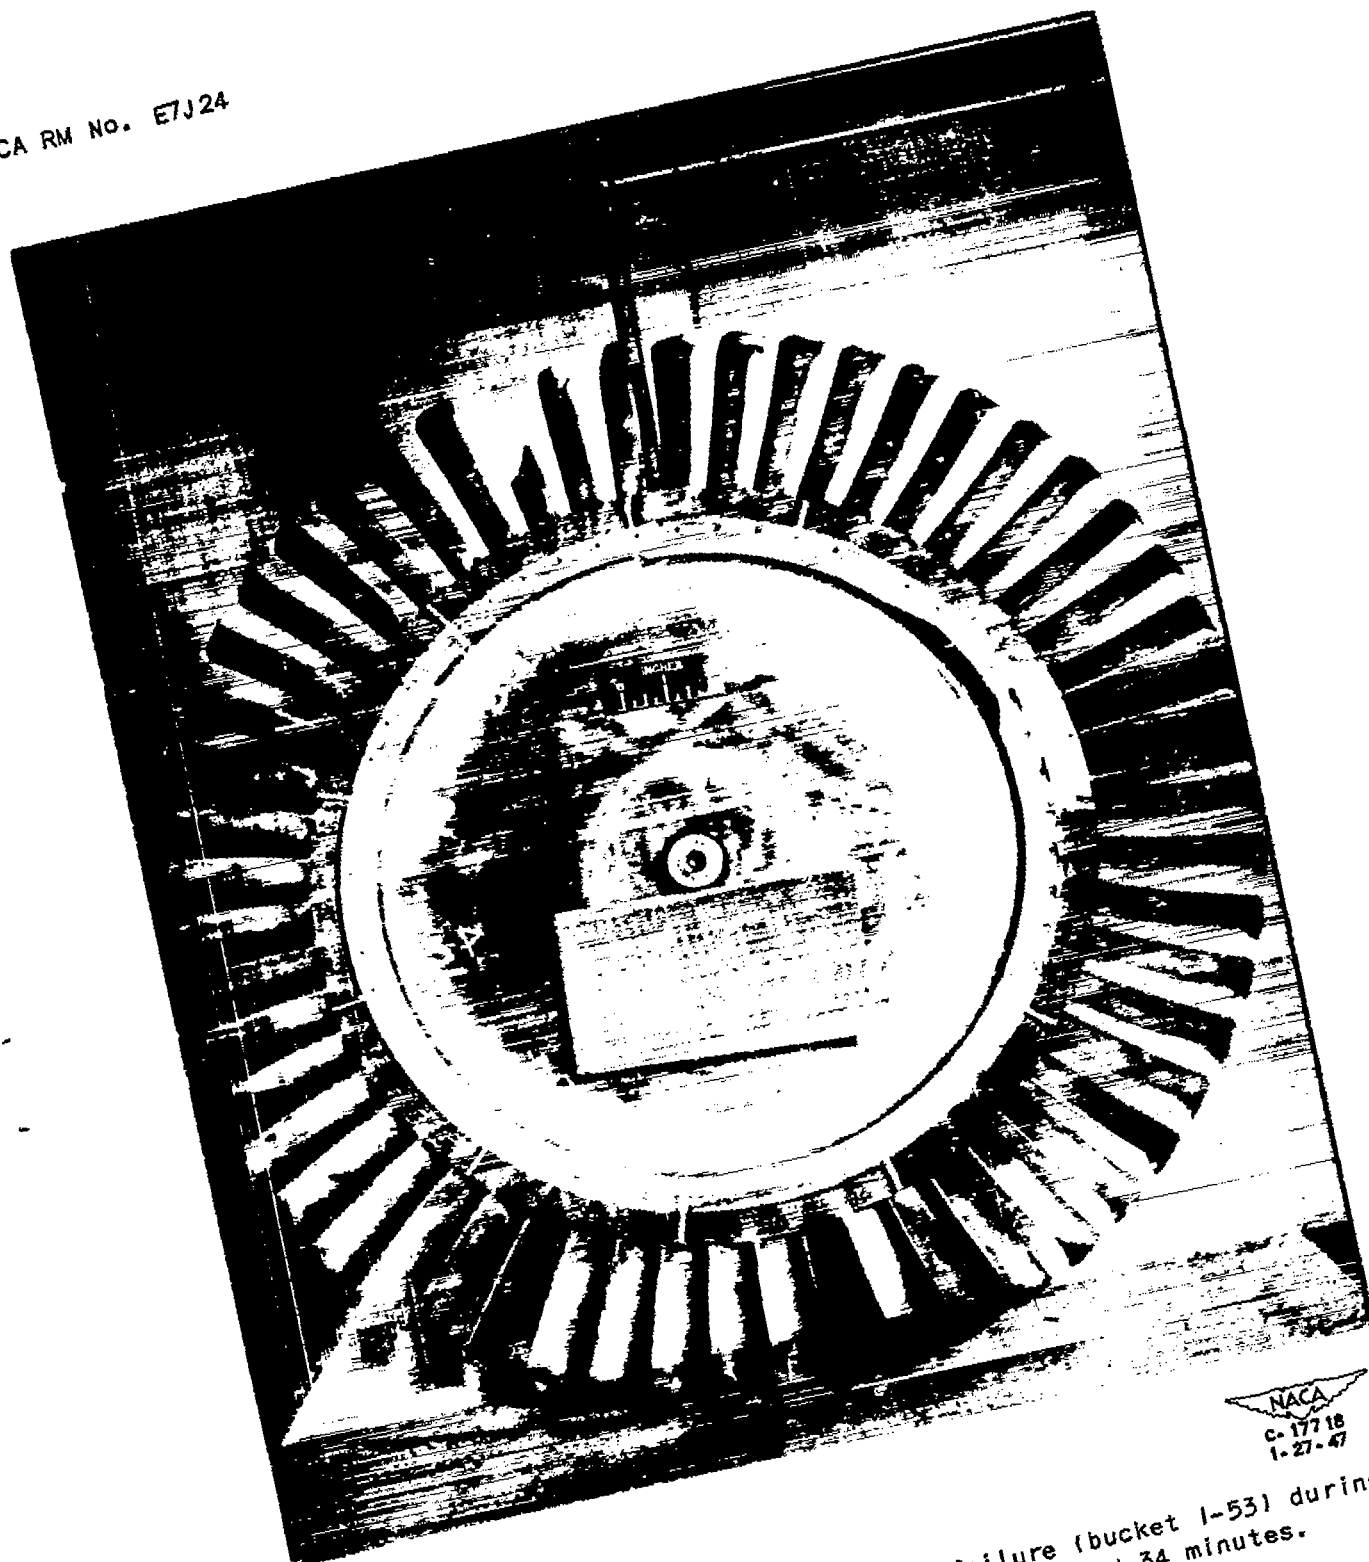
Wheel 1. - The first and second bucket failures, in cycle 22 at 7 hours and 20 minutes and in cycle 25 at 8 hours and 12 minutes, respectively, are described in reference 1. The third bucket, 1-53, broke in cycle 26 at a total running time of 8 hours and 34 minutes (fig. 2).

Figure 2. - Wheel 1 after third bucket failure (bucket 1-53) during  
test 26 at total running time of 8 hours and 34 minutes.

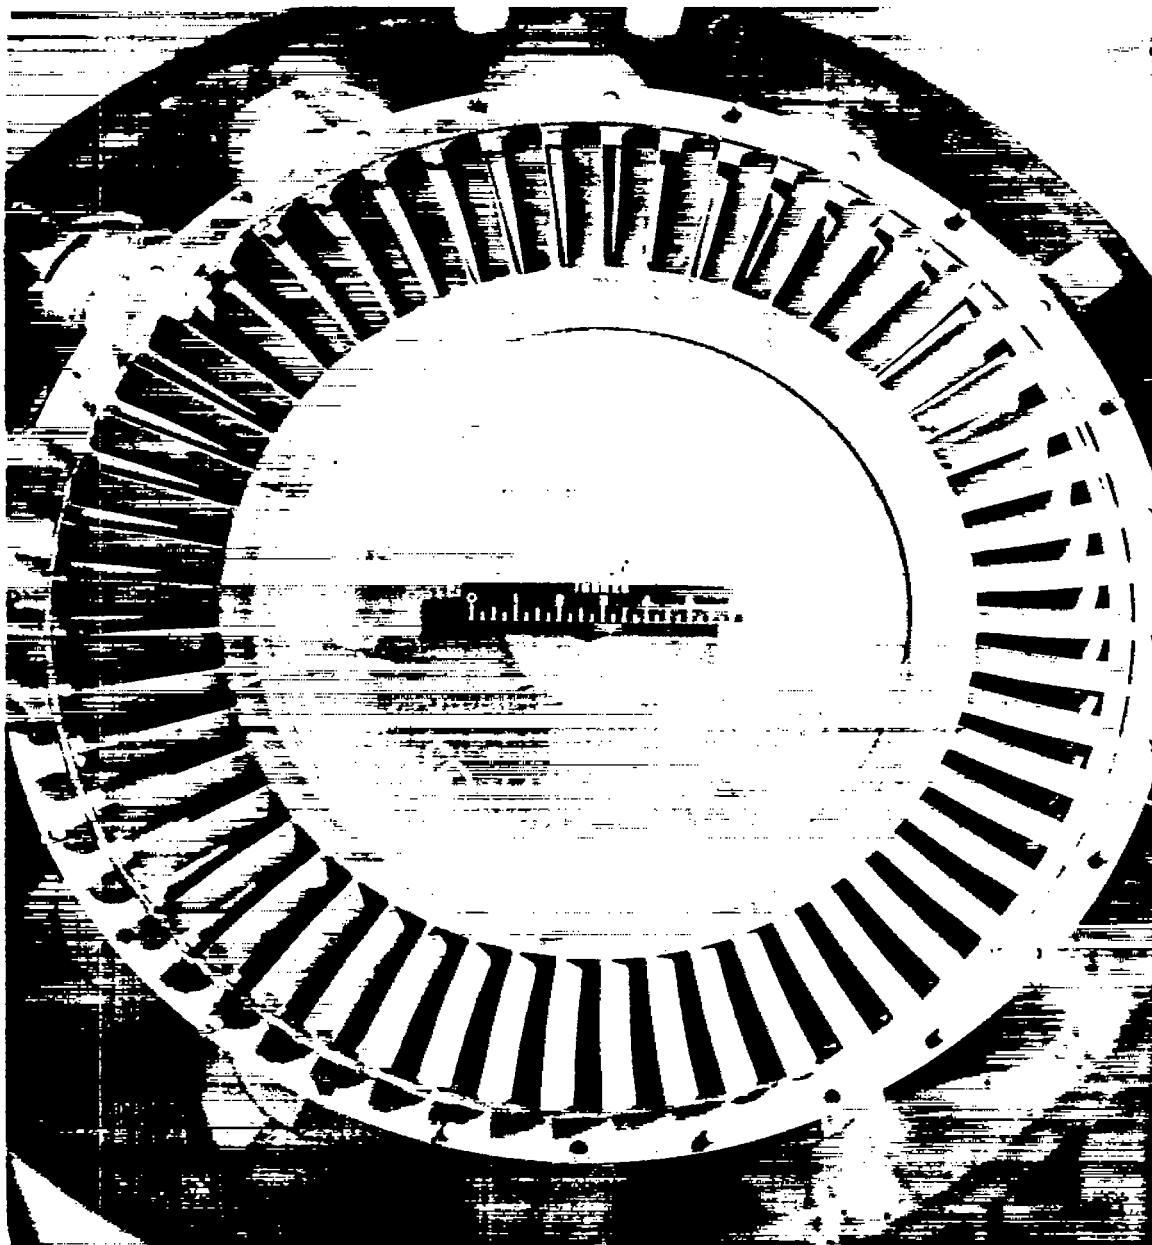
Wheel 2. - The first bucket failure (bucket 2-18) occurred in cycle 29 at 9 hours and 28 minutes (reference 1). The second bucket, 2-48, broke in cycle 106 at a total running time of 35 hours and 10 minutes (fig. 3).

Figure 3. - Wheel 2 after second bucket failure (bucket 2-48) during cycle 106 at total running time of 35 hours and 10 minutes.

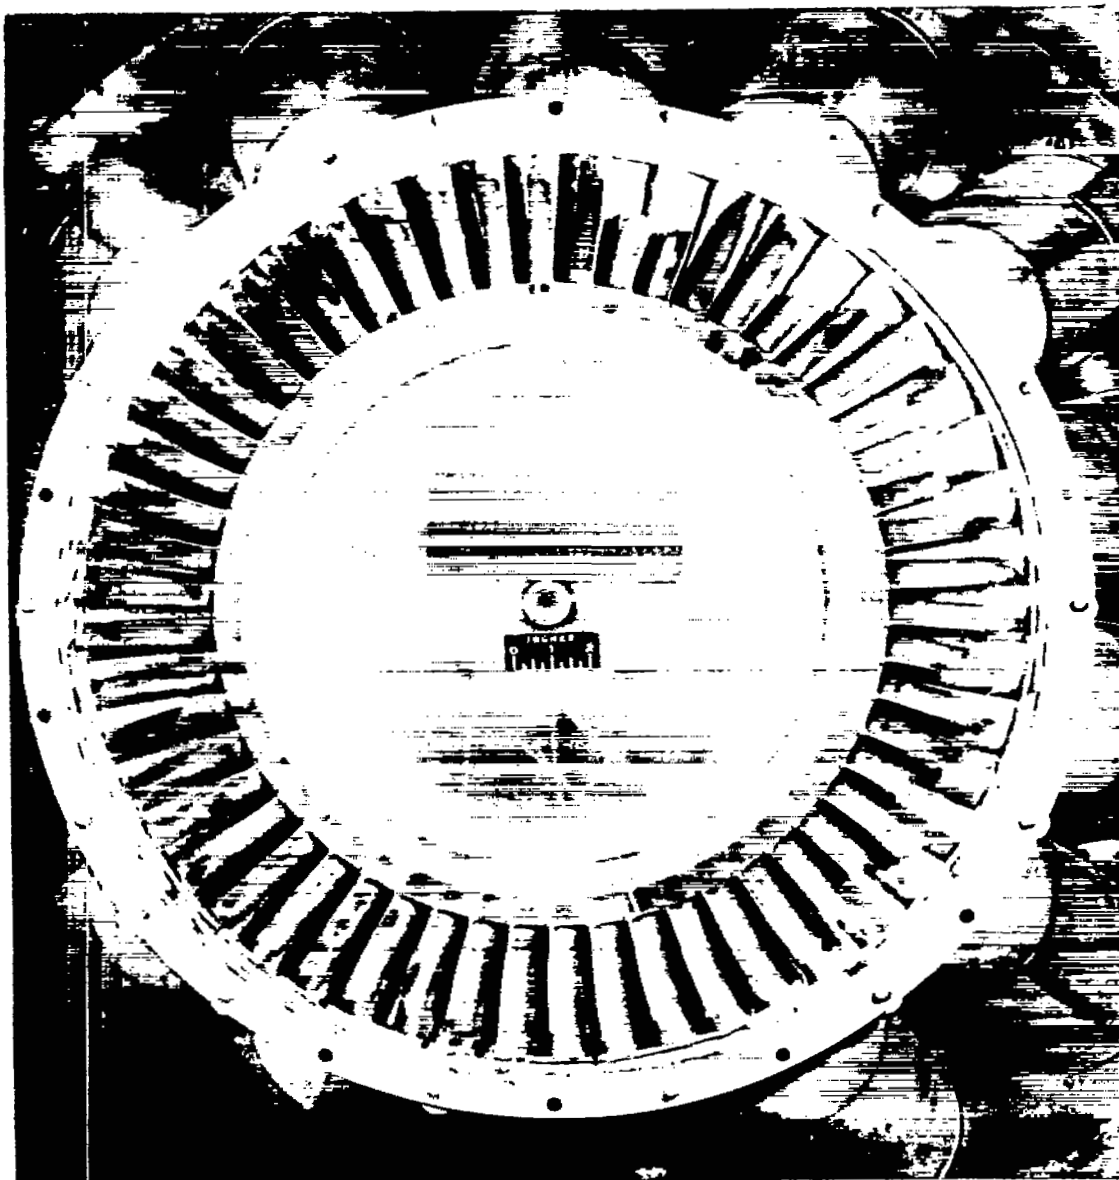
Wheel 3. - Buckets 3-16 and 3-43 were removed for examination after cycle 229 at 76 hours and 20 minutes total running time. Two new buckets were installed, the wheel balanced and the running continued. Upon inspection after cycle 260 (86 hr, 40 min, total running time), bucket 3-34 was found to be cracked on the convex surface. This bucket was replaced, the wheel balanced, and the running continued. In cycle 268 (89 hr, 17 min), a failure occurred that broke eight buckets and so damaged the others that running could not be continued with this wheel (fig. 4). Four of the eight broken buckets (3-33, 3-36, 3-45, and 3-49) were removed for examination.

Figure 4. - Wheel 3 after second bucket failure occurred during cycle 268 at total running time of 89 hours and 17 minutes damaging eight buckets.

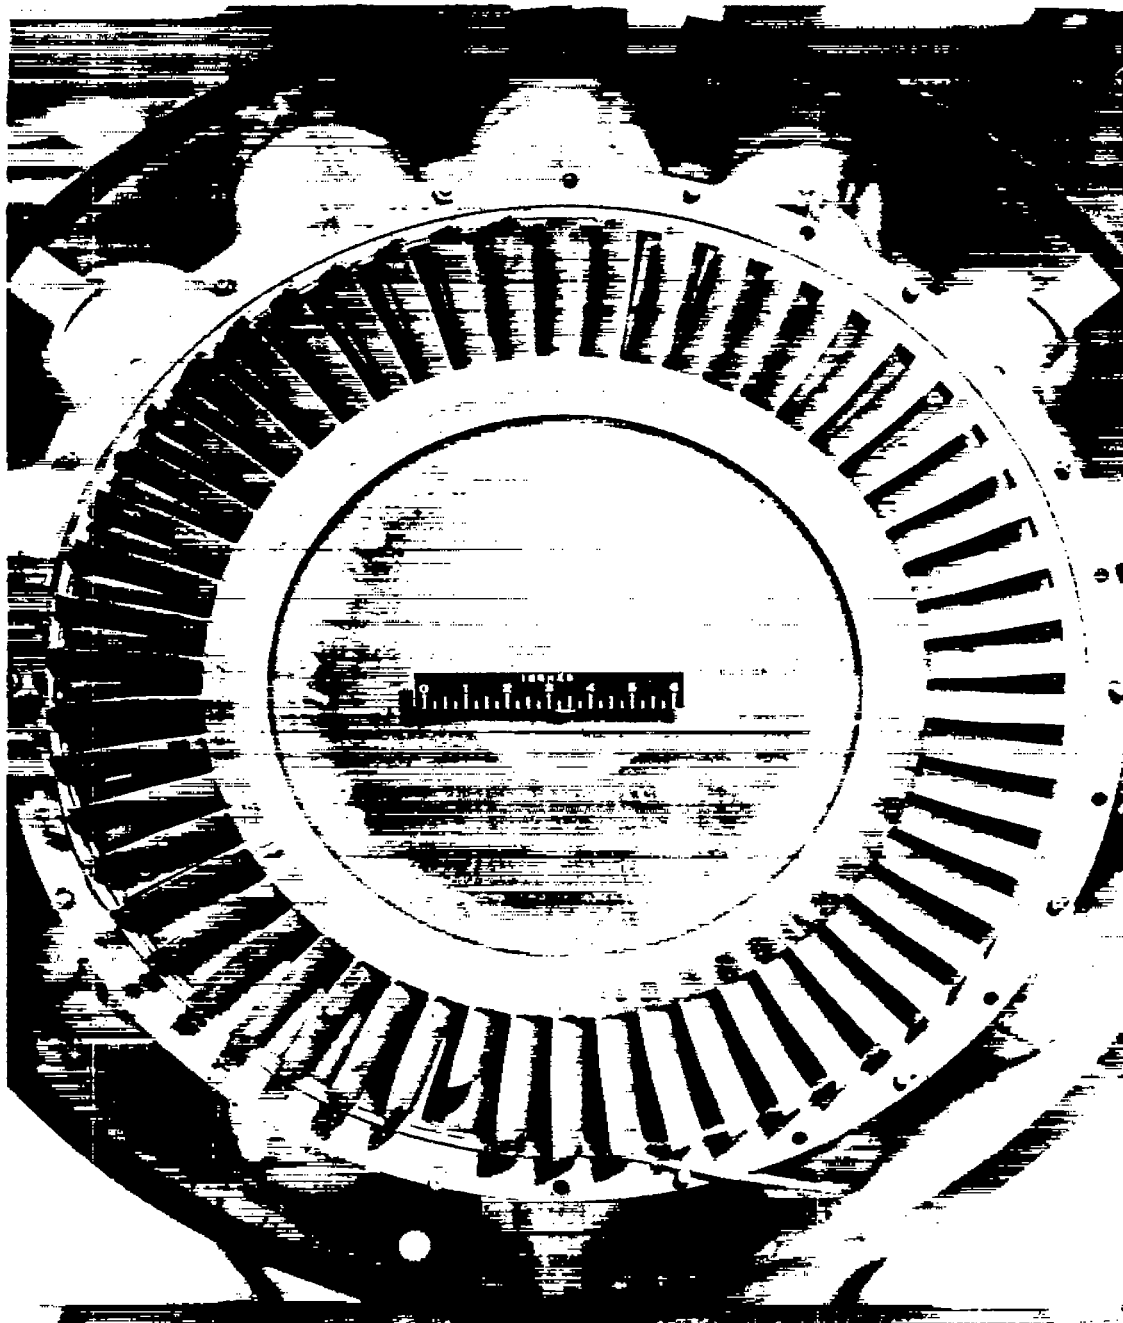
Wheel 4. - The first bucket, 4-28, failed in cycle 156 at a total running time of 51 hours and 57 minutes (fig. 5). The broken bucket and two unbroken ones, 4-1 and 4-29, were removed from the wheel for examination. Three new buckets were installed, the wheel balanced, and the running continued. In cycle 188 (62 hr, 37 min, total

Figure 5. - Wheel 4 after first bucket failure (bucket 4-28) during cycle 156 at total running time of 51 hours and 57 minutes.

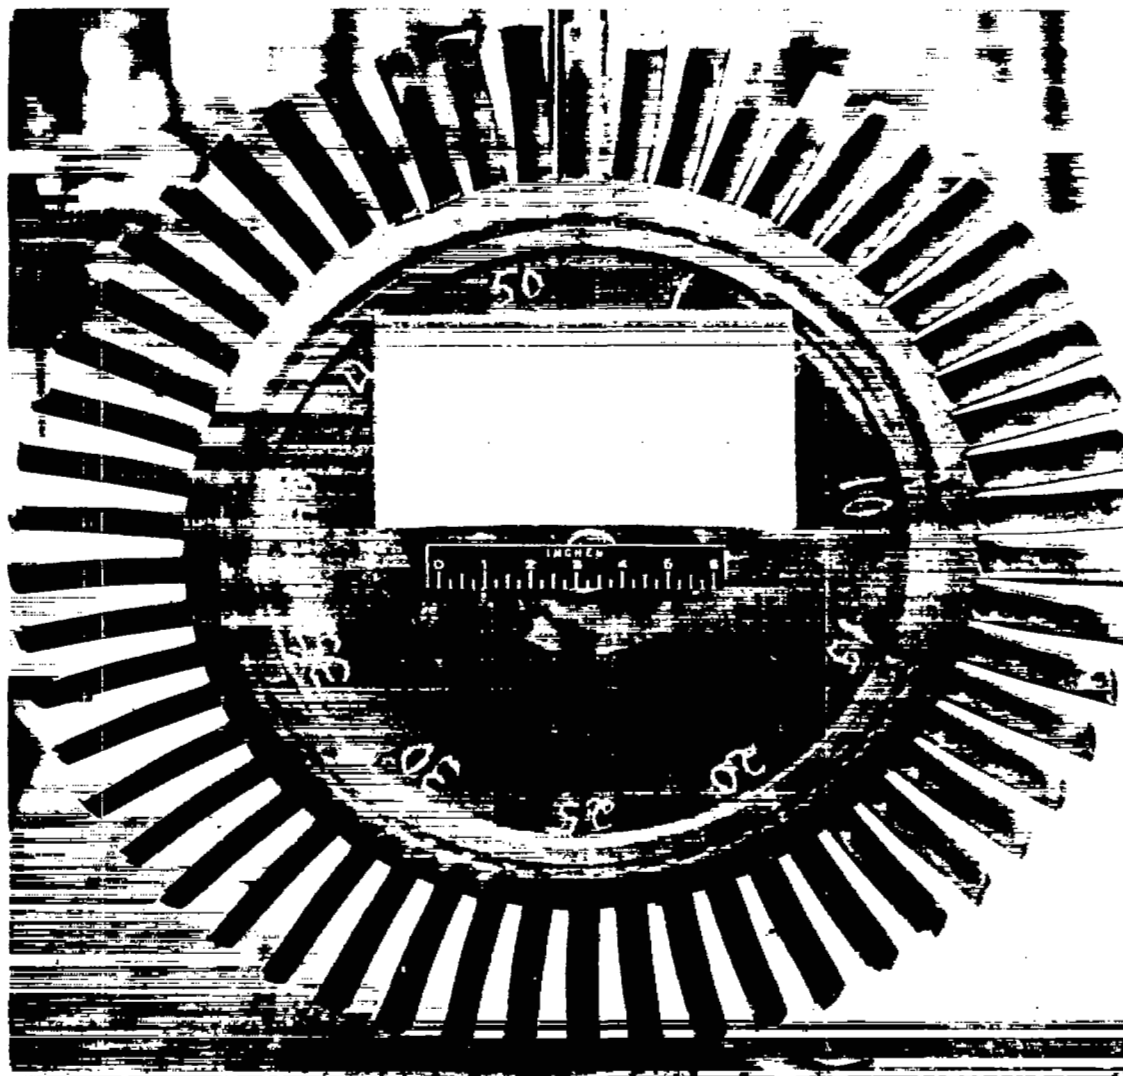
running time), bucket 4-1A broke. This bucket (fig. 6) was one installed after the first failure and had been operated for 32 cycles (10 hr, 40 min). The bucket was replaced, the wheel balanced, and the running continued. The third bucket, 4-39, broke during cycle 190 at a total running time of 63 hours and 16 minutes (fig. 7).

Figure 6. - Wheel 4 after second bucket failure (bucket 4-1A) during cycle 188 at total running time of 62 hours and 37 minutes. This bucket was installed after first bucket failure and was run 32 cycles (10 hr, 40 min).

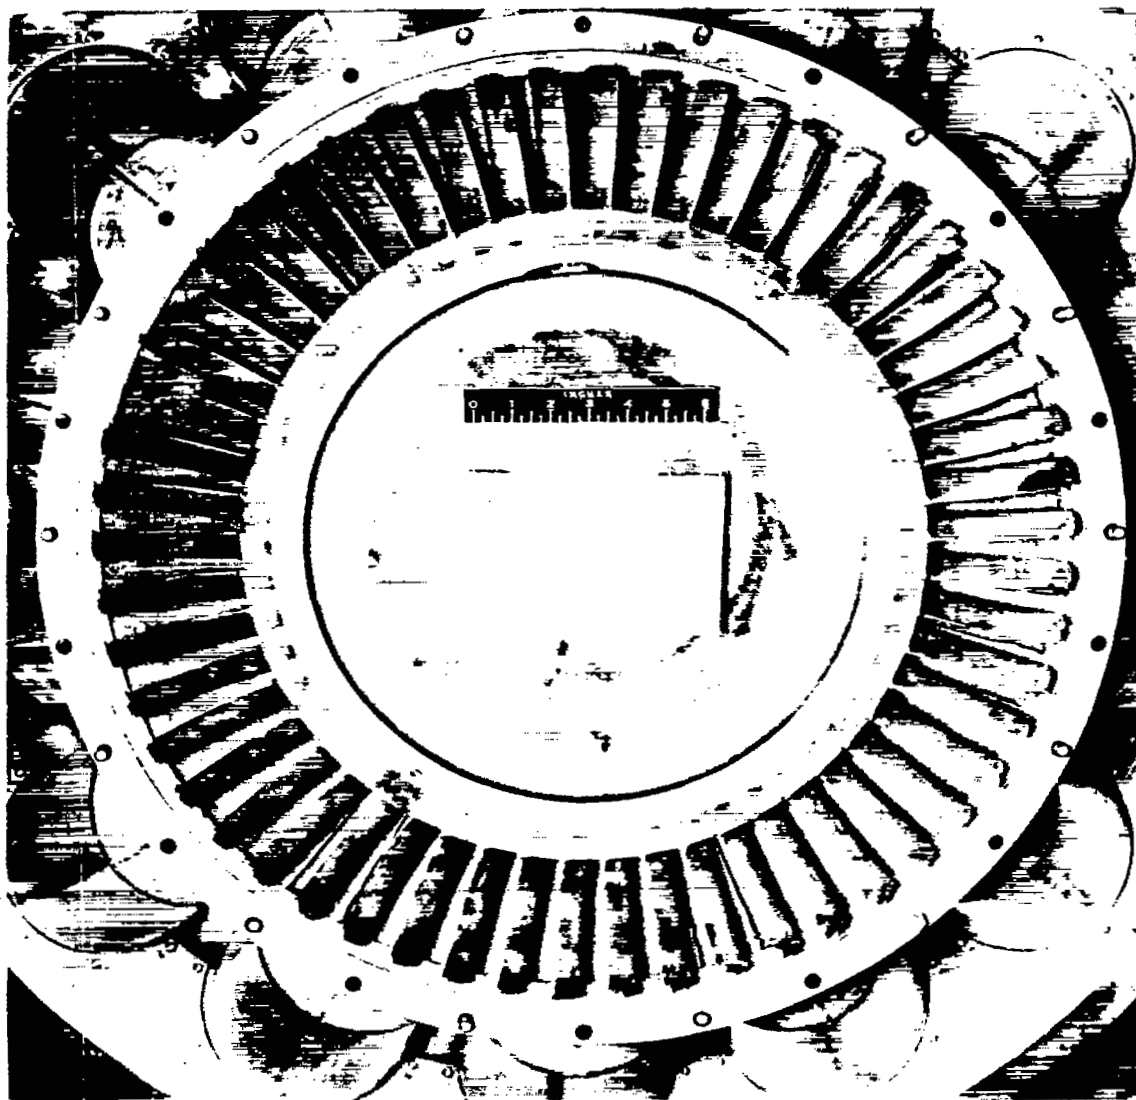
Figure 7. - Wheel 4 after third bucket failure (bucket 4-39) during cycle 190 at total running time of 63 hours and 16 minutes.

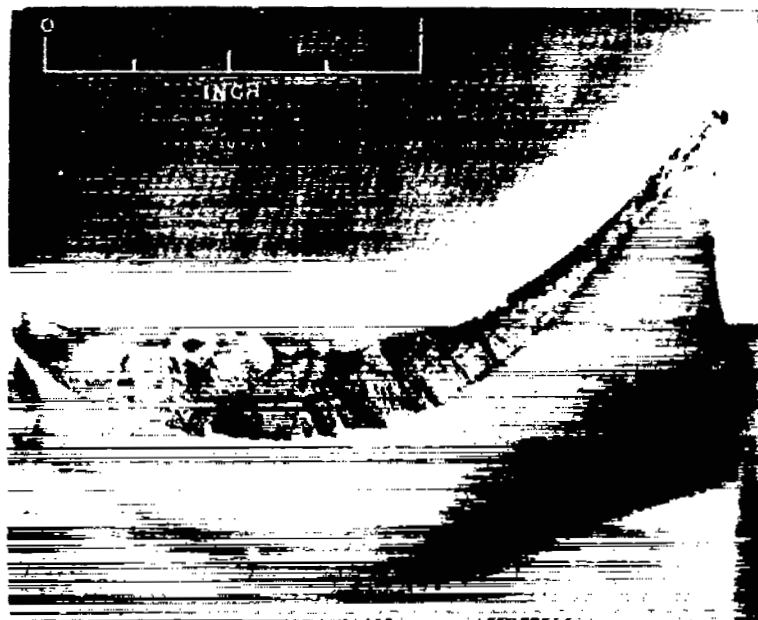
3. Appearance of the fracture faces of broken buckets permitted classification of the failures into primary and secondary failures, examples of which are shown in figures 8(a) and 8(b), respectively.

4. The fracture faces of the eight primary-failure buckets exhibited three distinct zones that are quite different in appearance (fig. 8(a)). One zone has a smooth appearance and is coated with a tight oxide film ranging in color from light straw to dark gray. Contrary to data presented in reference 1, this zone occurred randomly at either edge and in one case at the center of the bucket. This apparent discrepancy in the results was probably caused by the increased number of buckets examined in this investigation. The second zone had the fibrous appearance that is characteristic of fractured ductile material and was coated with a loose porous oxide film ranging in color from a deep blue to dull gray or black. The third zone was a transitional one between the other two zones both in location and in characteristics. Fractures of the primary class were transcrystalline across the entire bucket and occurred in the center third of the blade length (fig. 9(a)). These observations lead to the conclusion that the primary type of failure is caused by fatigue, which originates in the smooth zone and progresses until the centrifugal stress on the remaining portion of the blade exceeds the ultimate strength of the material and the blade fails in tension. The location of the origin of fatigue within the smooth zone was extremely difficult to determine, particularly because the fractured surface was always coated with a thick oxide layer, which was difficult to remove by methods that did not damage the fracture face.

(a) Primary failure,  
caused by fatigue.

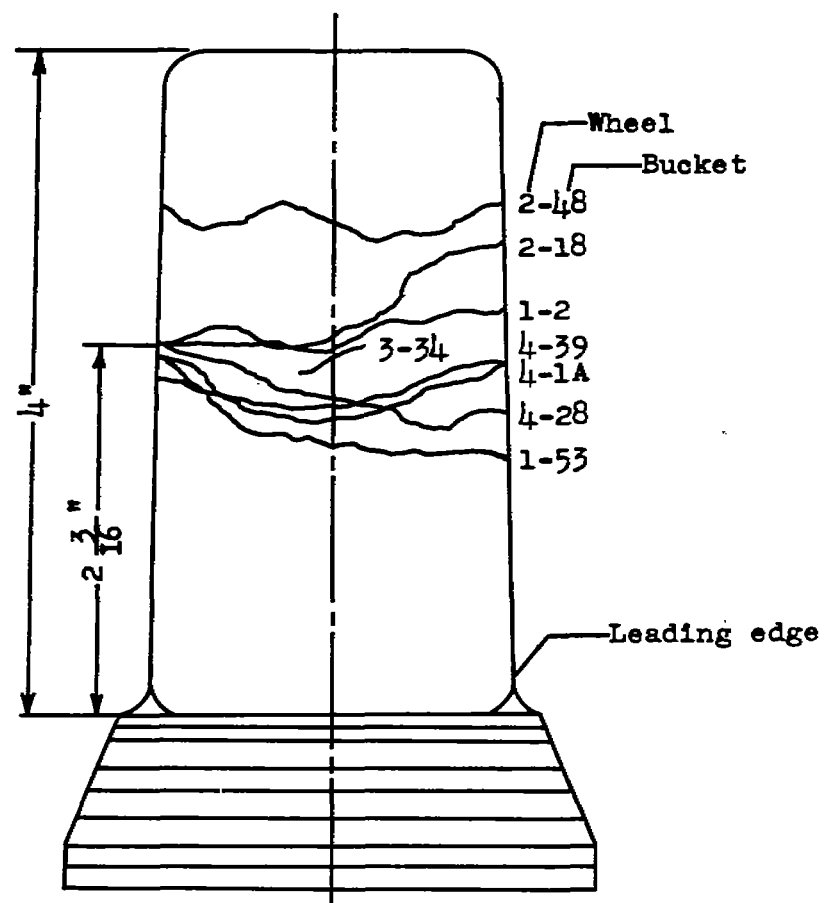
(a) Failures caused by fatigue.

Figure 9. - Composite profile of failures of cast Vitallium turbine buckets.

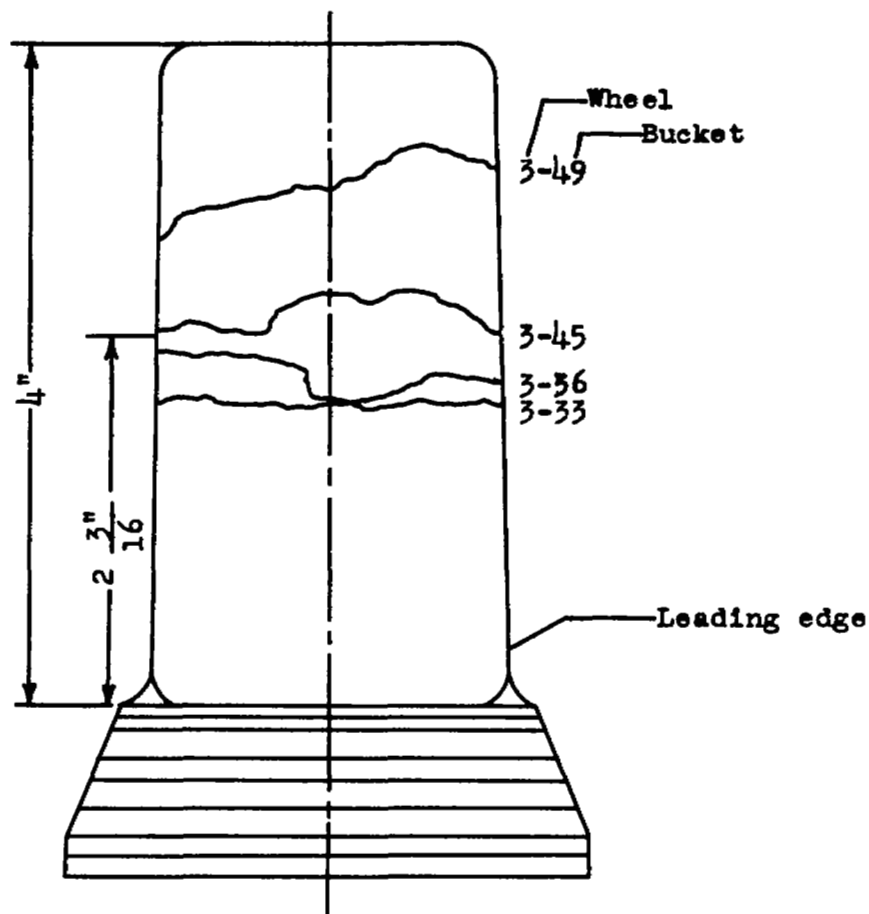
5. The fractured faces of four buckets representative of the secondary type of failure (fig. 8(b)) exhibited an appearance, uniform across the entire bucket, that was similar both in color and in texture to the fibrous zone previously described. This type of failure was also transcrystalline and had a random distribution along the blade length (fig. 9(b)). These failures probably occurred upon impact with segments of other broken buckets.

(b) Failures probably caused by impact.

Figure 9. - Concluded. Composite profile of failures of cast Vitallium turbine buckets.
